**APPENDIX B**

**SITE VISIT PHOTOGRAPHS**

**PARCEL 1**

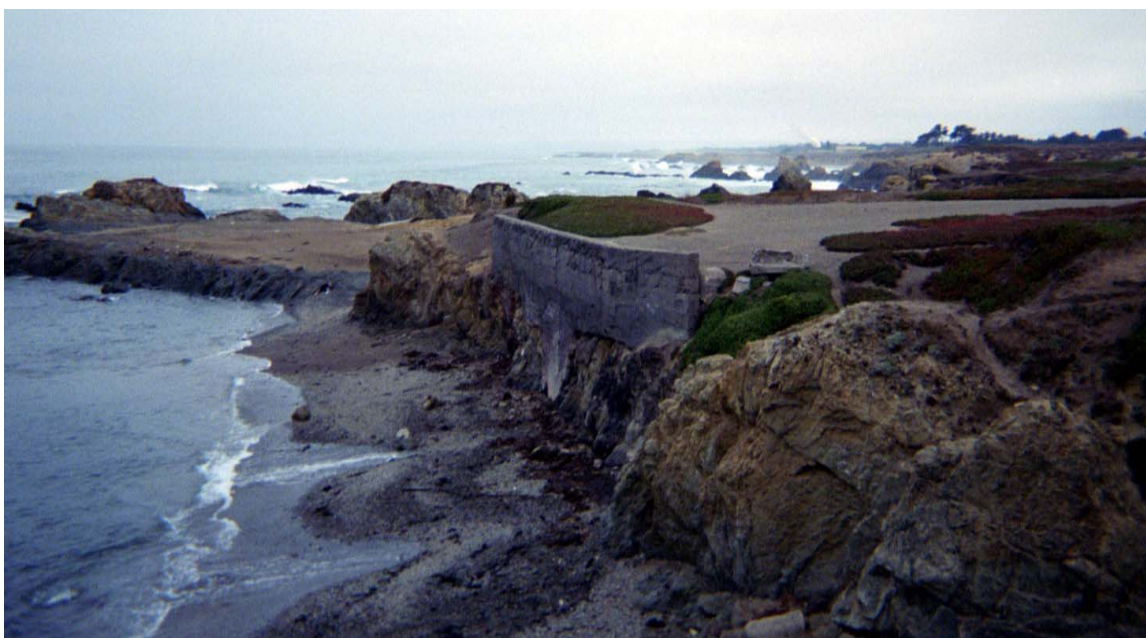
Photo 2. William J. Blinn Trust Site – North of G-P Property.

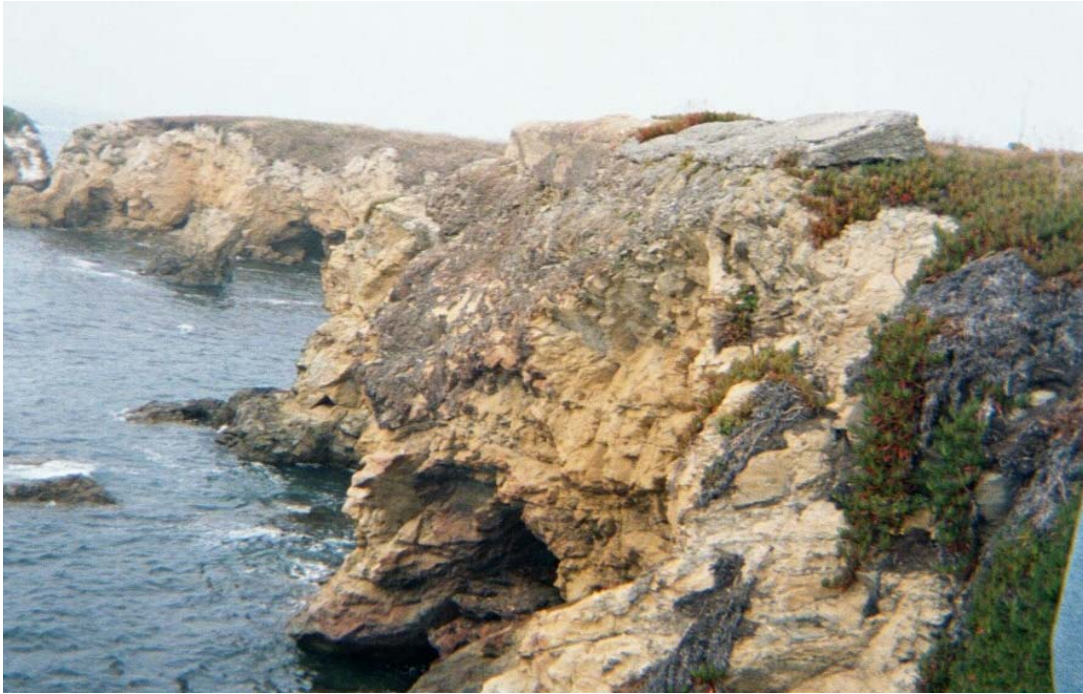
Photo 5. Glass Beach #2.

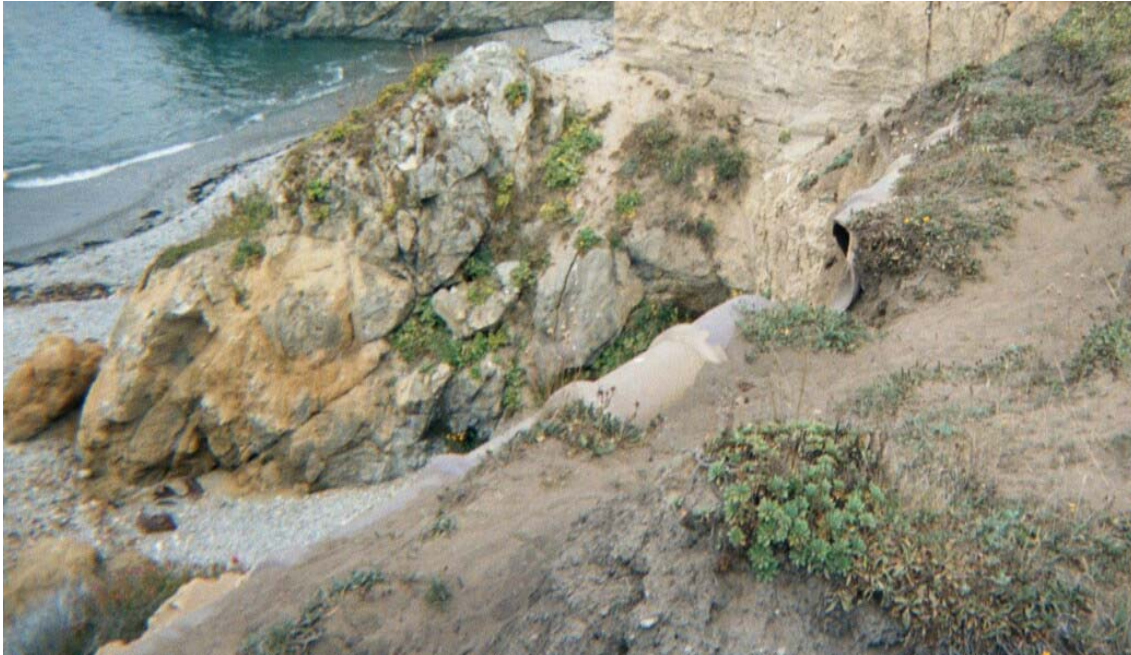
Photo 7. Old Sewer Pipeline.

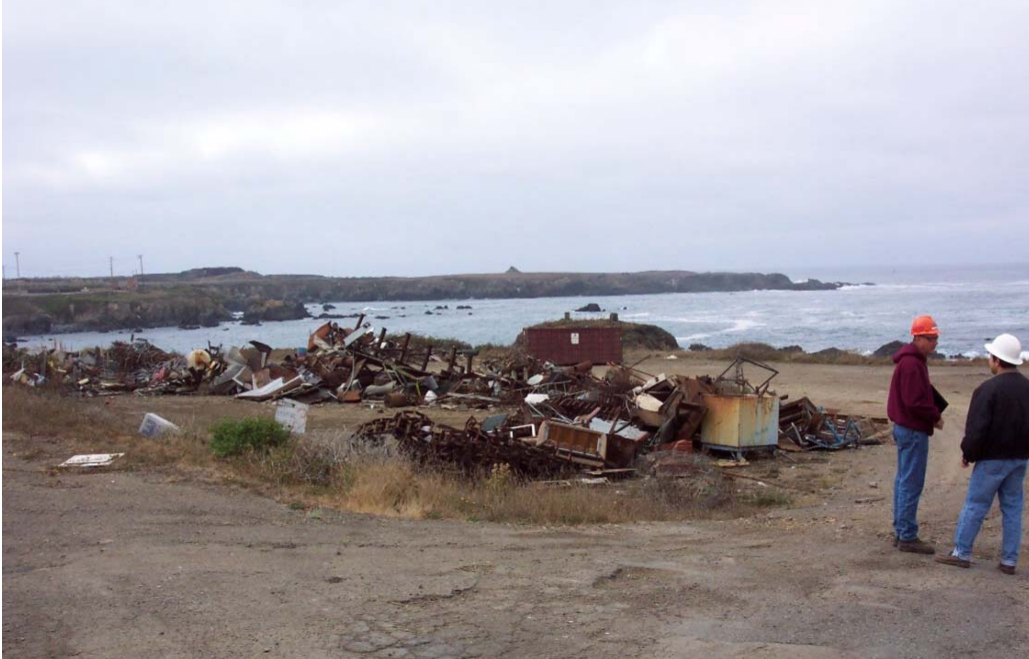
Photo 1. View of Scrap Yard area. Debris has been removed.

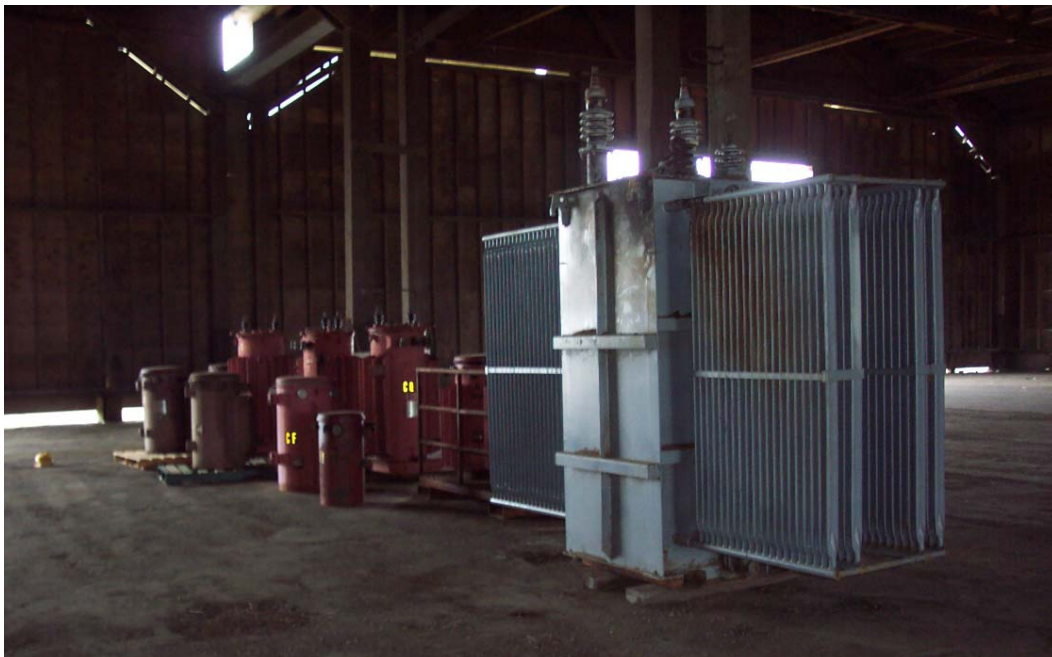
Photo 2. Empty transformers in the Truck Loading Shed. Transformers have been removed.

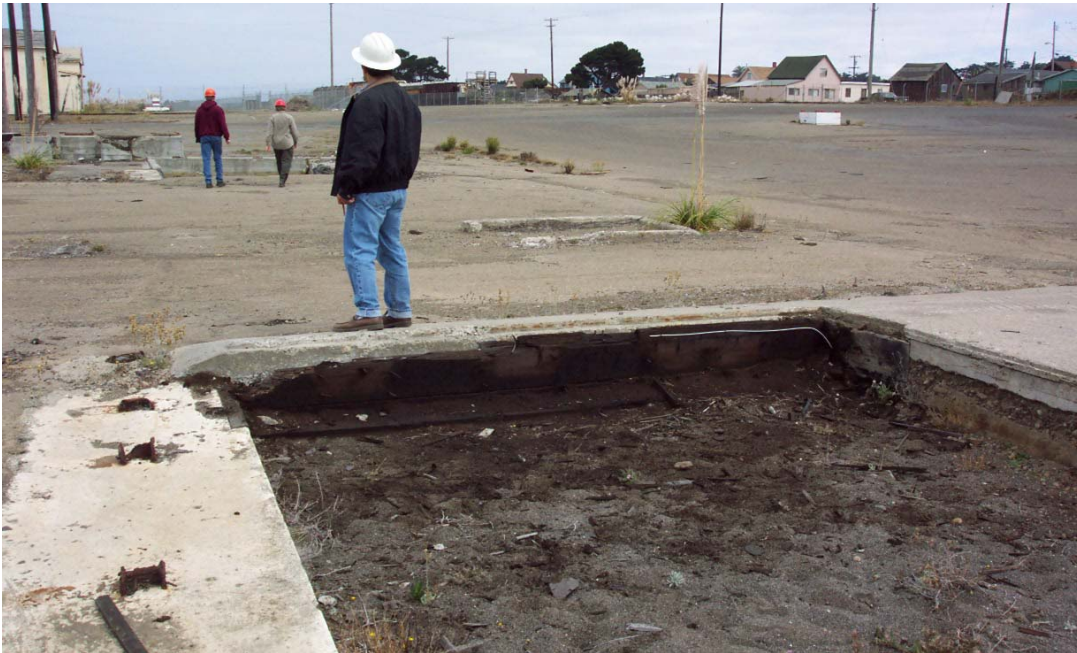
Photo 3. One of two sand pits at Former Planer No. 1.

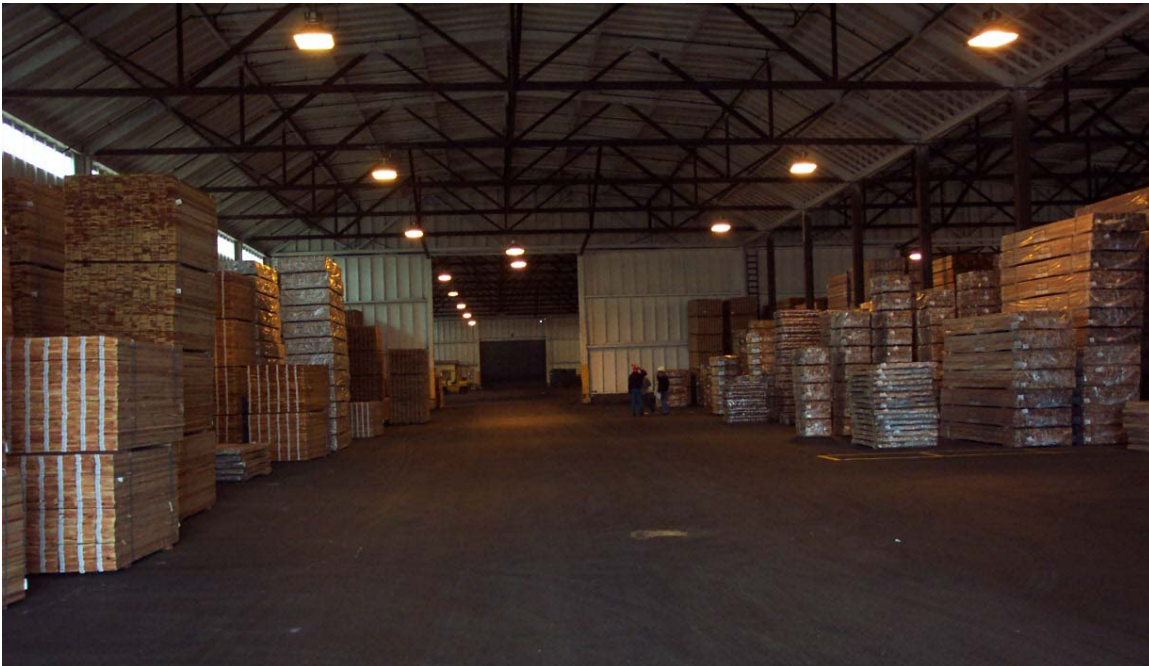
Photo 6. View of interior of Dry Shed No. 4.

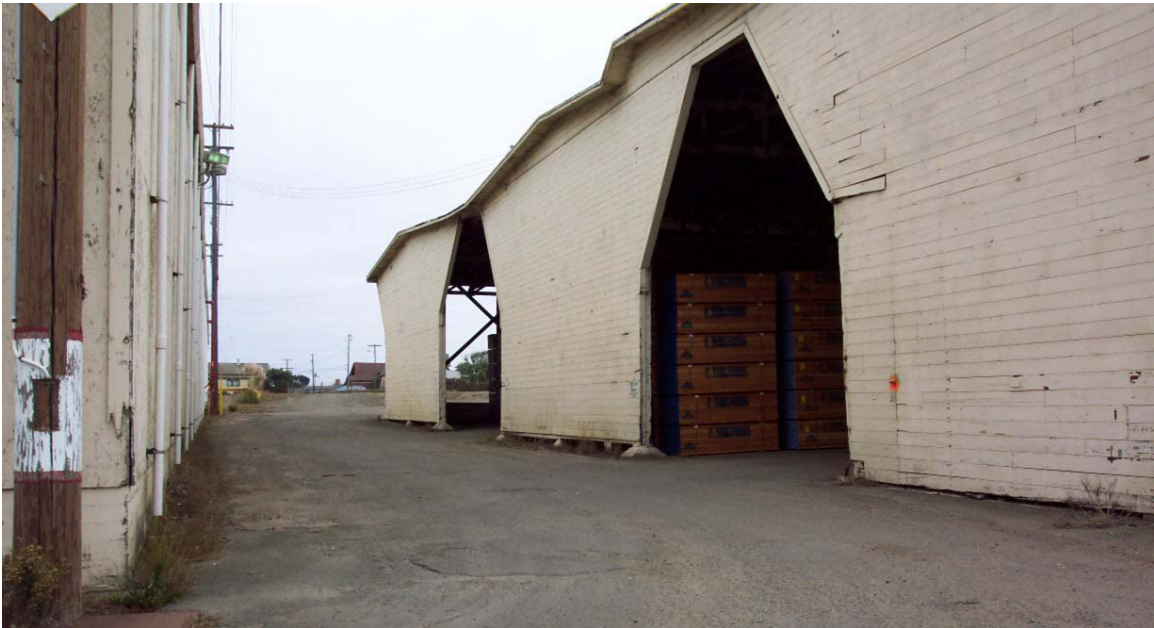
Photo 7. View of exterior of Dry Shed No. 5 (Dry Shed No. 4 on left side).

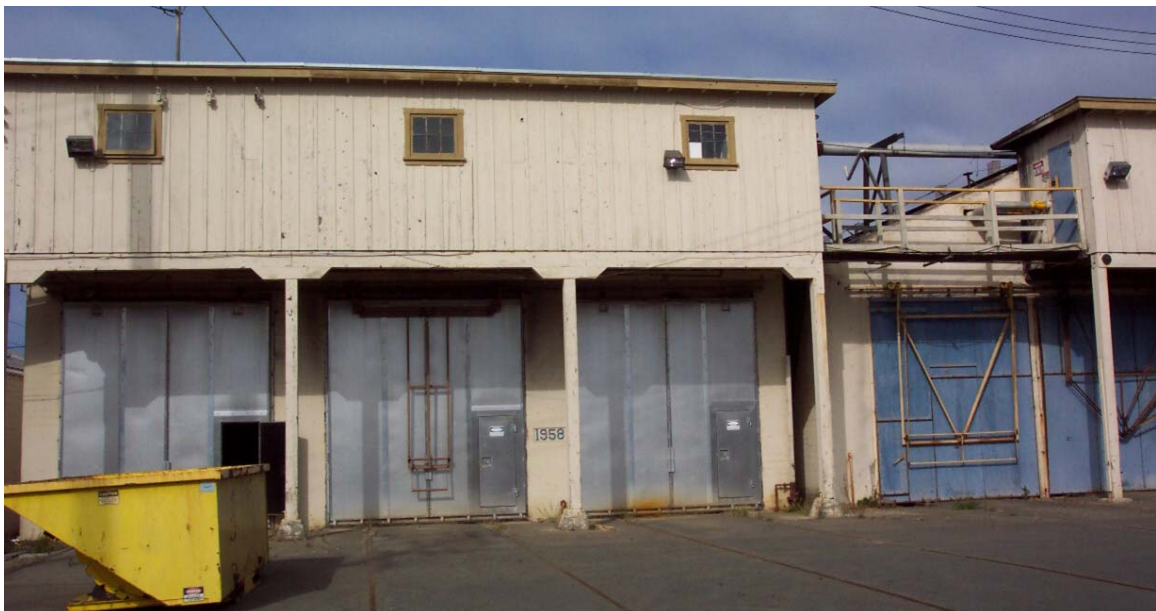
Photo 12. View of Kilns.

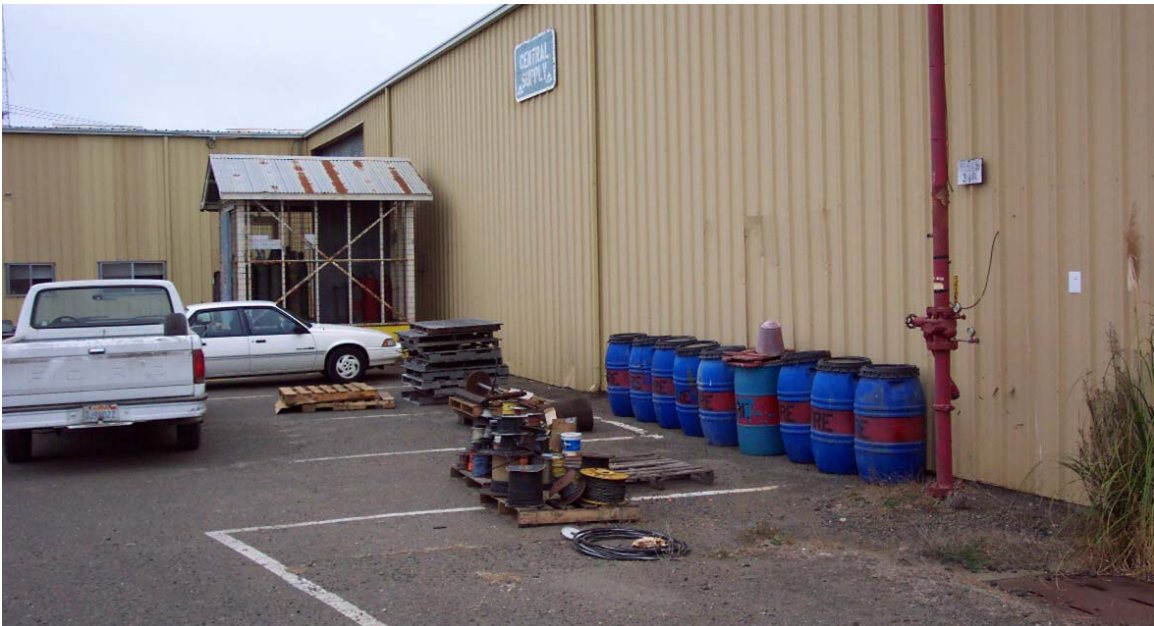
Photo 18. Paint containers outside Plant Supply. Oxygen, argon, and carbon dioxide in locked shed in background. Containers and debris have been removed.

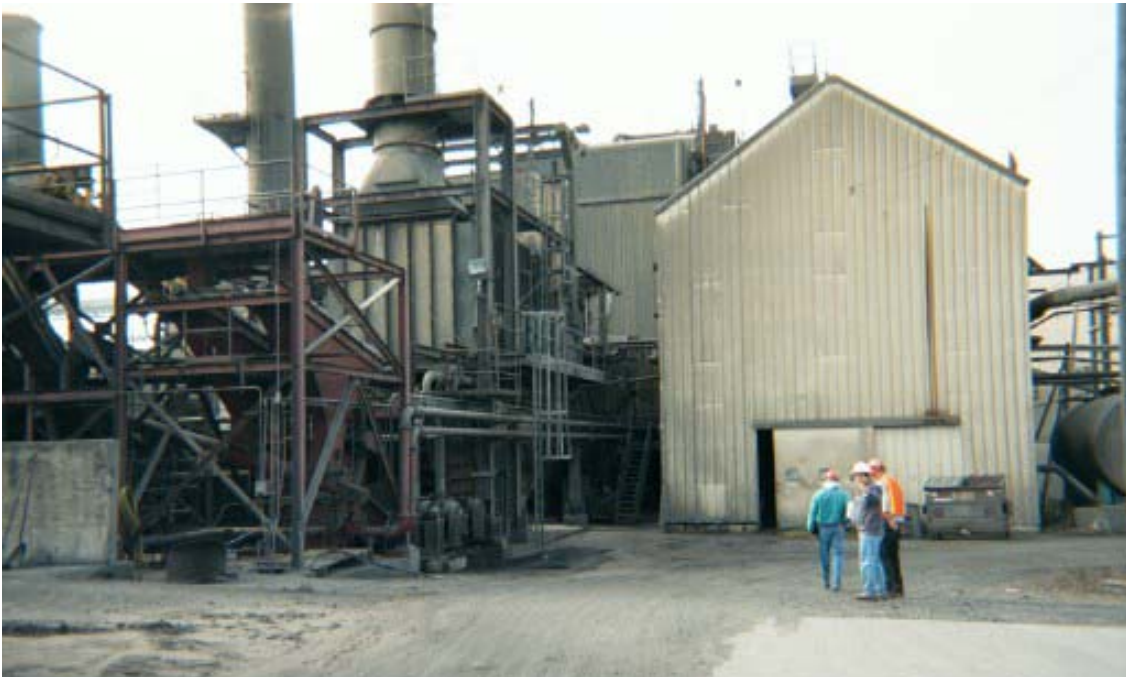
Photo 9. View of northeast side of power house.

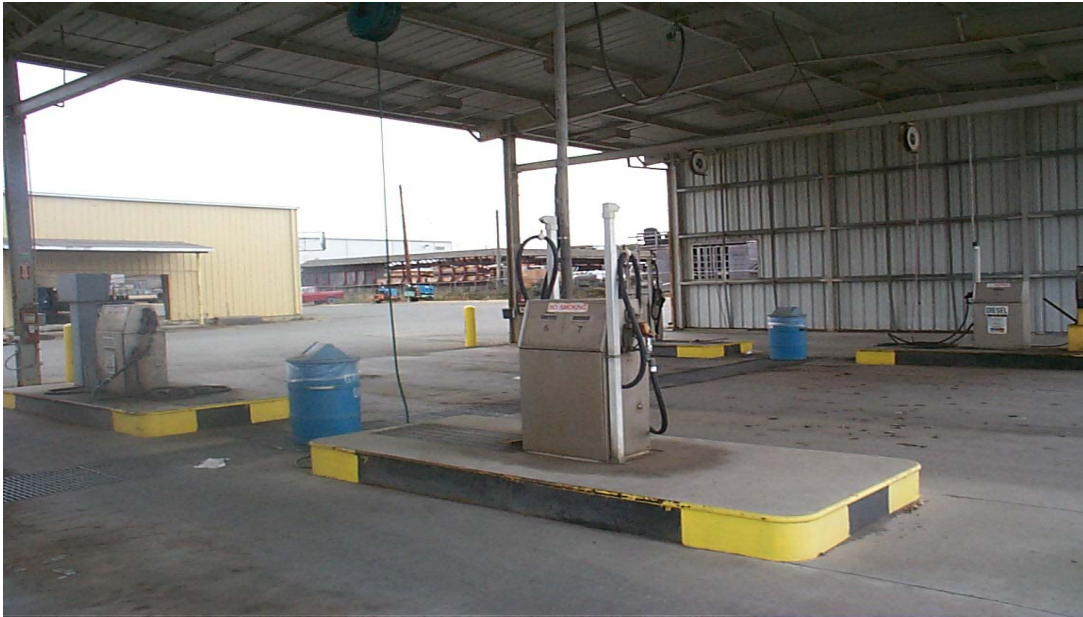
Photo 1. Fuel Storage and Dispenser Building.

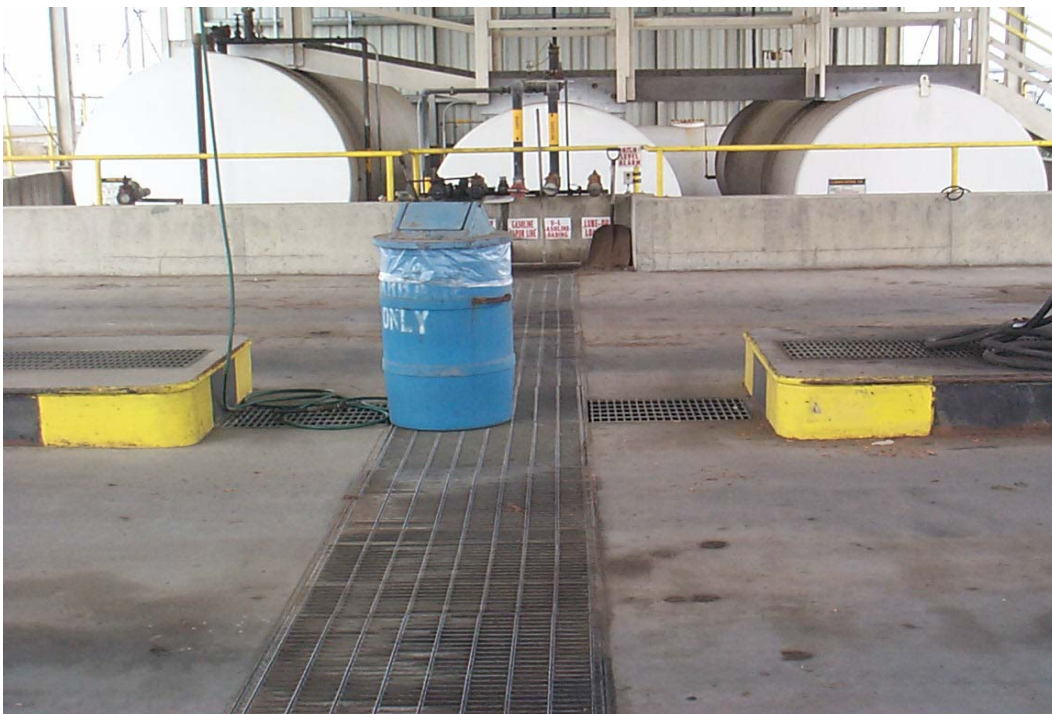
Photo 2. Concrete conduit in Fuel Storage and Dispenser Building with fuel pipes.

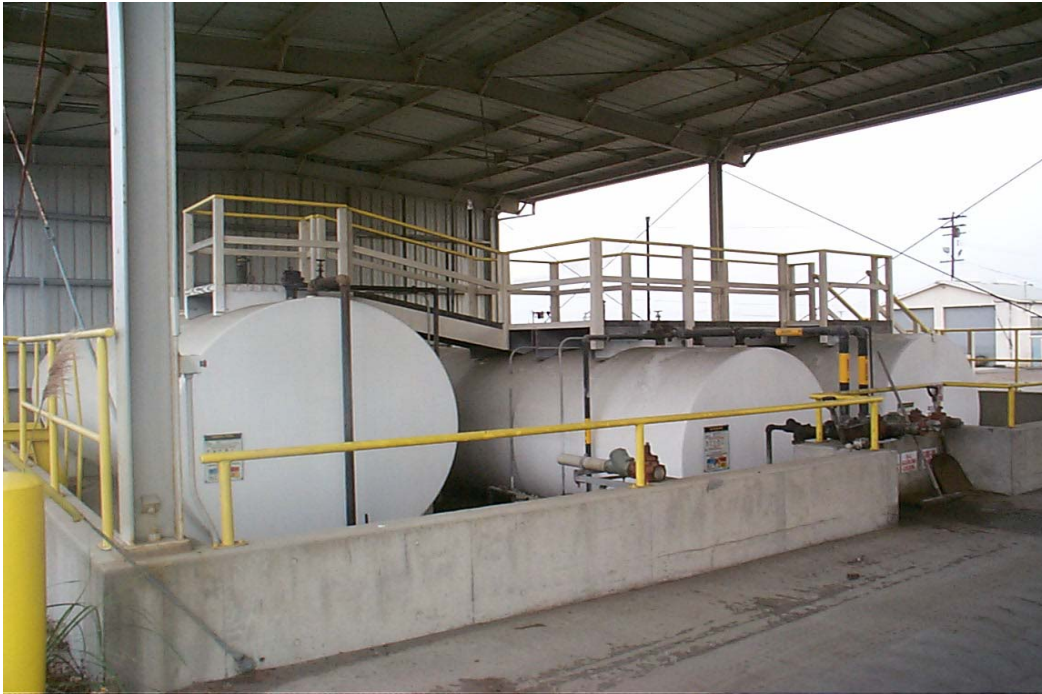
Photo 3. ASTs located inside Fuel Dispenser and Storage Building. ASTs have been removed.

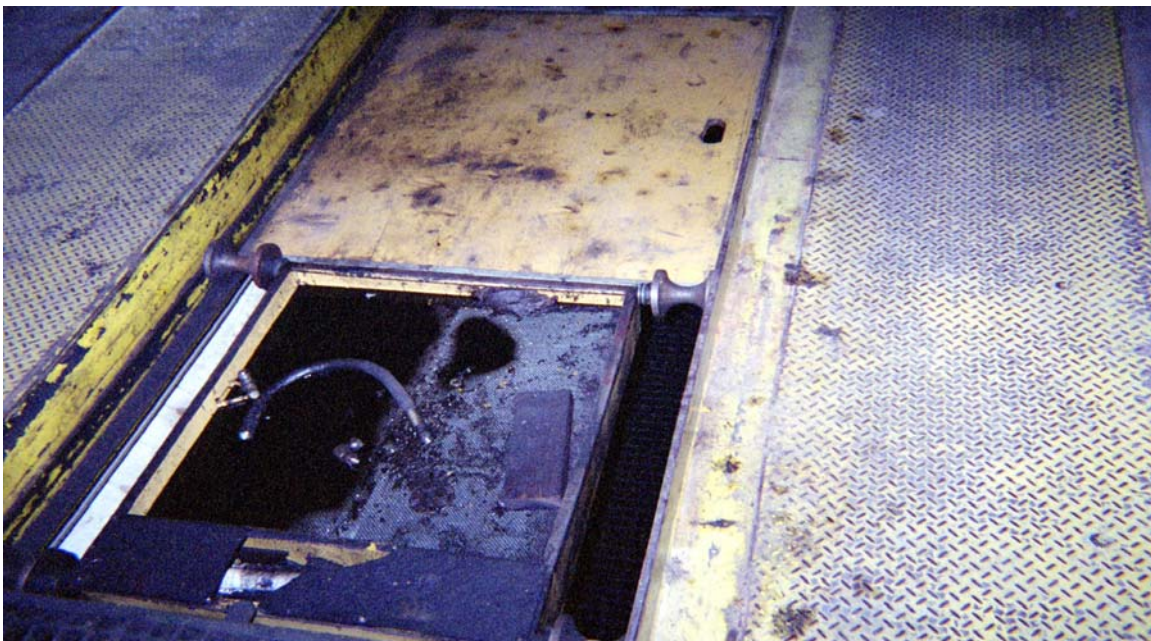
Photo 8. Oil Change Pit.

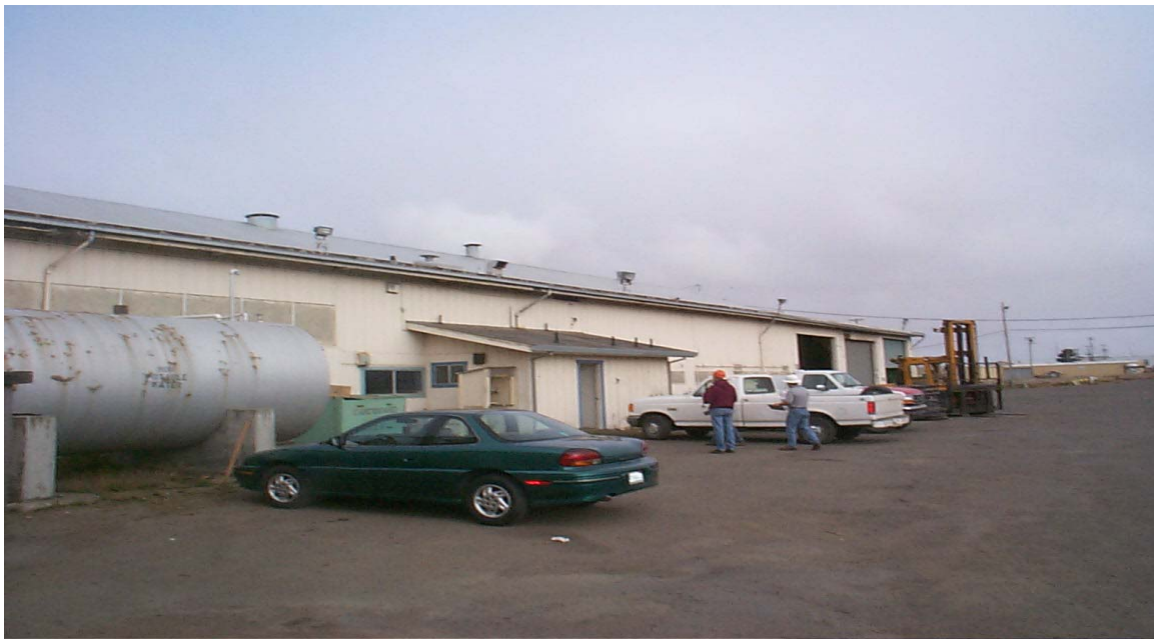
Photo 14. Eastern Side of Mobile Equipment Shop.

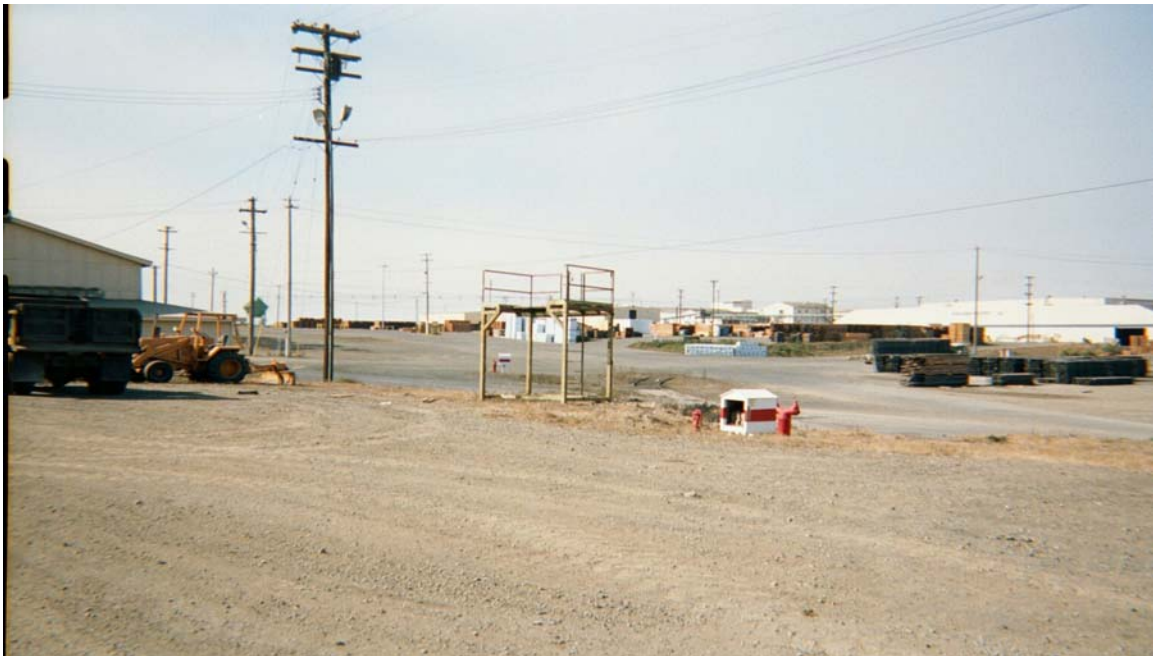
Photo 16. Area West of Mobile Equipment Shop – Possible old AST location

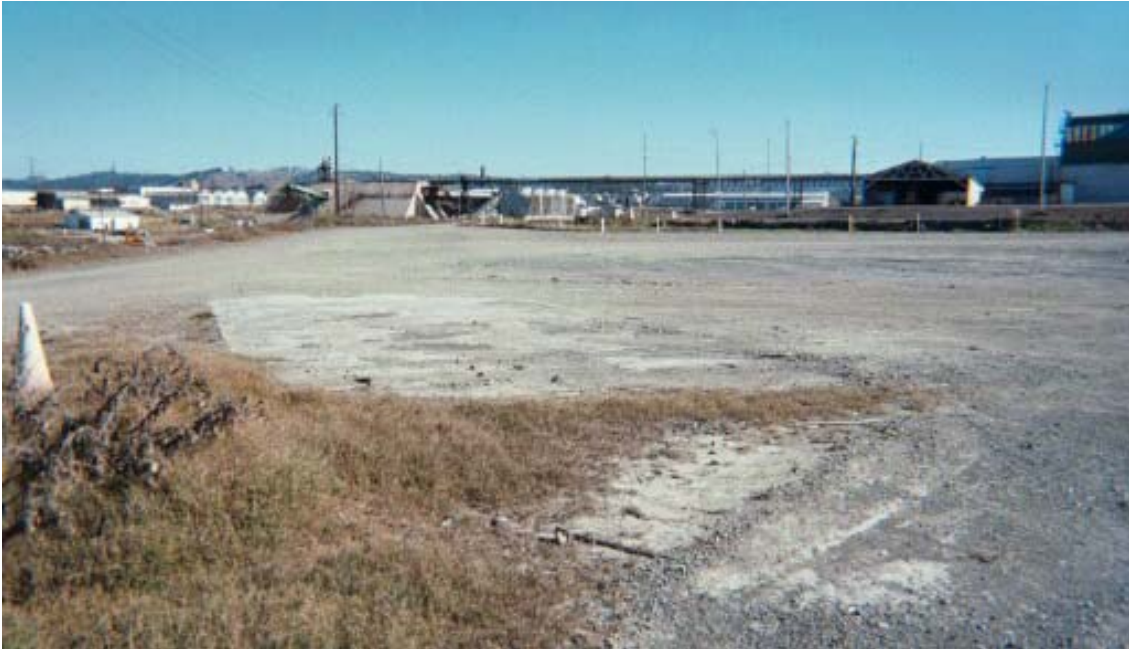
Photo 1. Concrete pad at former Cooling Towers location (looking northeast).

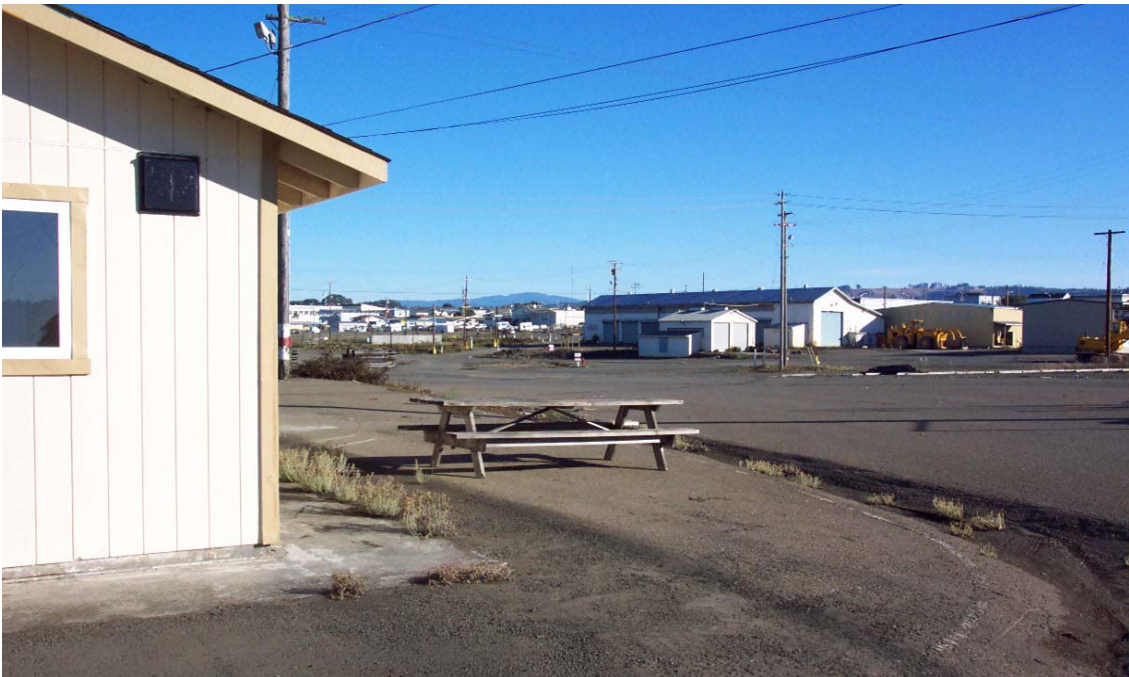
Photo 6. Estimated area of former fuel pump and diesel storage northeast of the Shipping Office, in the background.

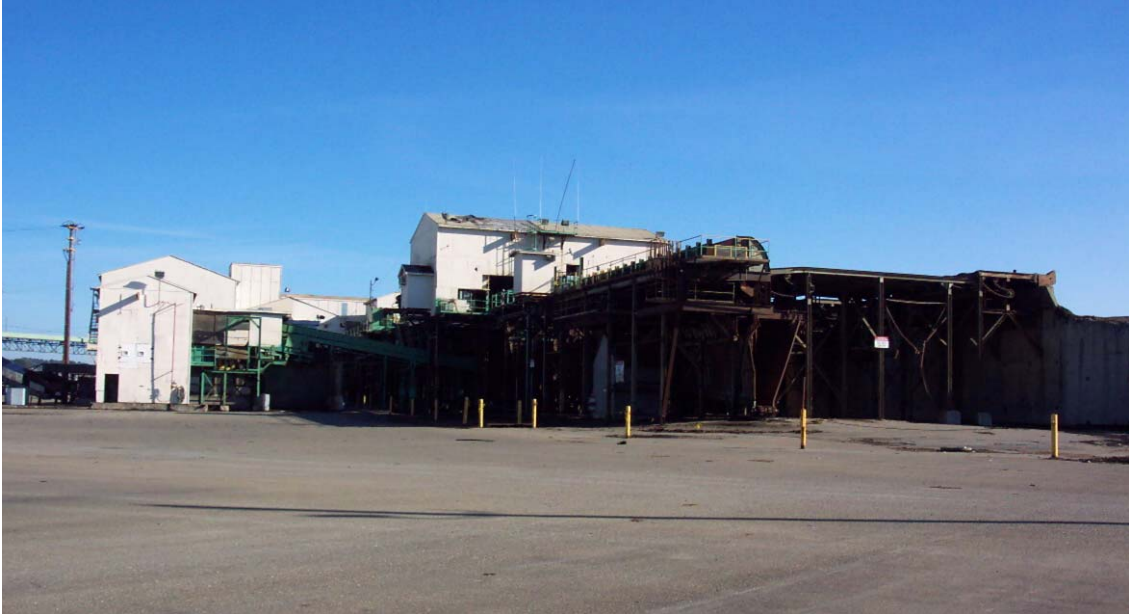
Photo 1. View of Sawmill No. 2 looking east.

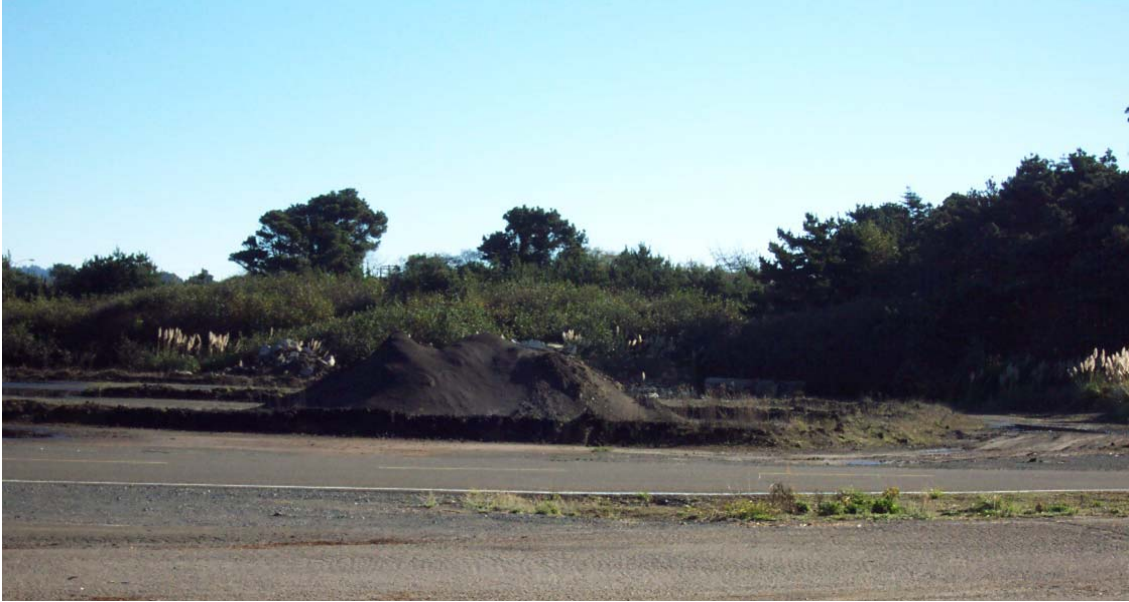
Photo 3. Sediment storage area.

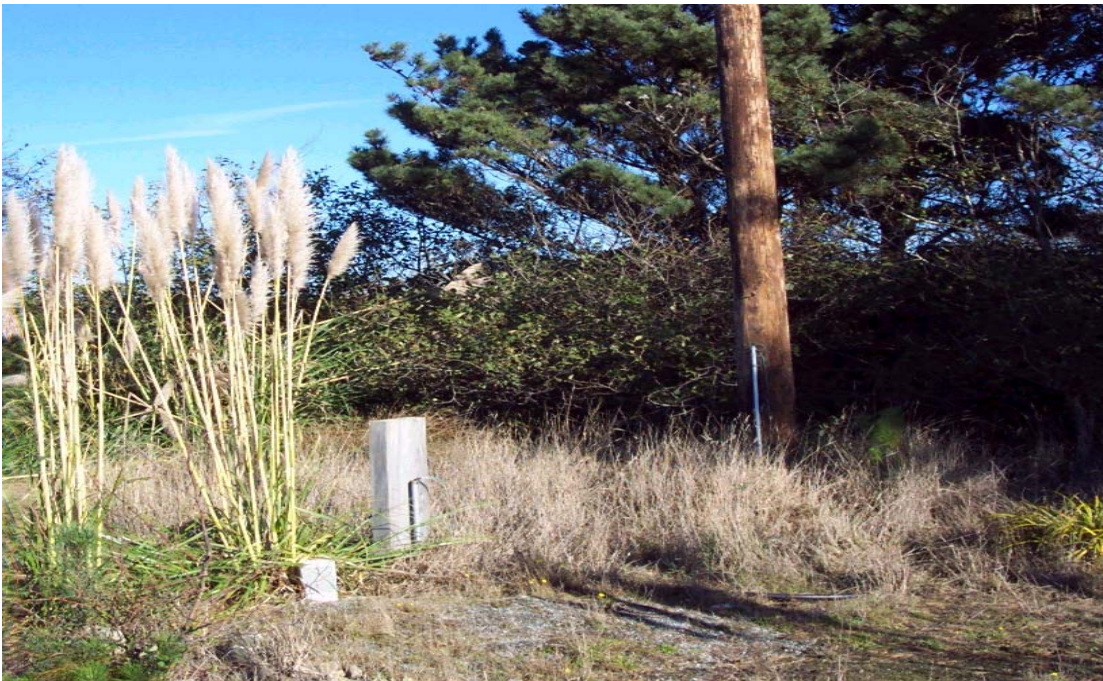
Photo 4. One of four groundwater wells along the east area of Parcel 7.

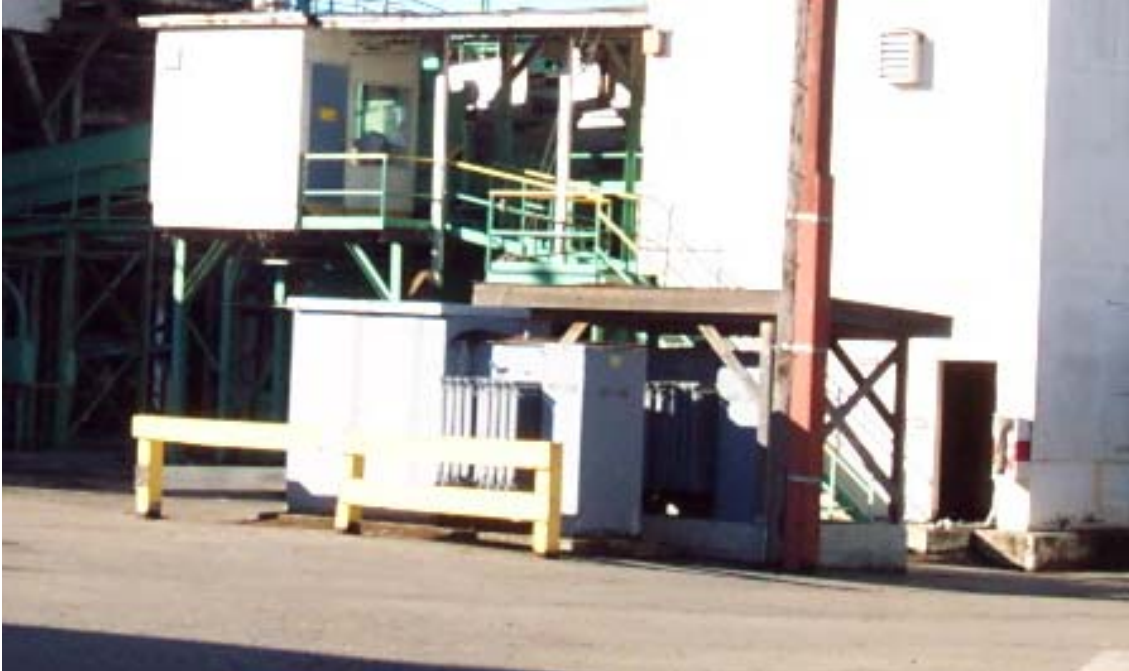
Photo 5. Transformers north of Sawmill No. 2.

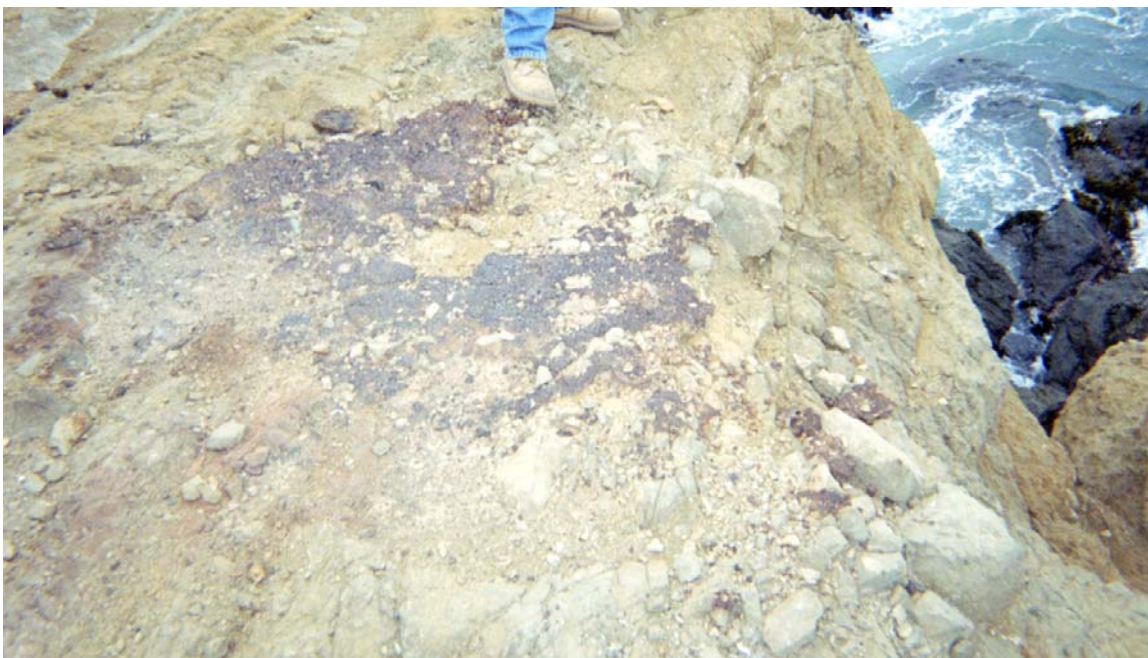
Photo 1. Coastline of Disturbed Area .

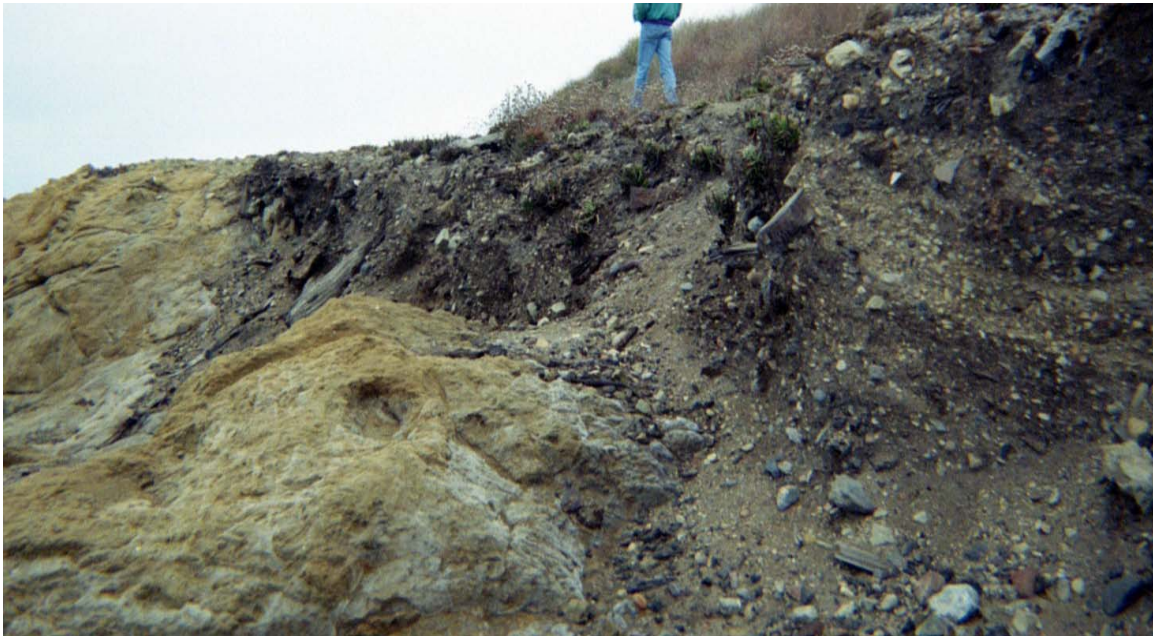
Photo 4. Clinkers and wood debris along coastline of Parcel 10.
